TITLE: Troubleshooting Vibration Problems. A Compilation of Case Histories

TROUBLESHOOTING VIBRATION PROBLEMS A COMPILATION OF CASE HISTORIES

Nelson L. Baxter
ABM Technical Services, Inc.
8529 E. CR. 300 S
Plainfield, In. 46168
ABM@SURF-ICI.COM

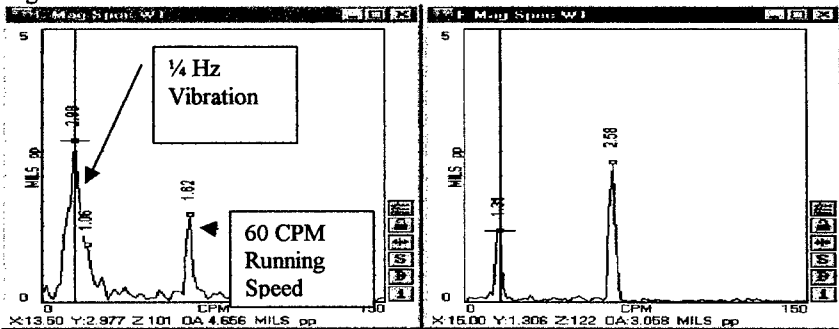
CASE 1- $\frac{1}{4}$ Hz vibration in Hydroelectric Dam. During the operation of a hydroelectric turbine, the whole structure would begin to shake in a certain load range. The problem was identified as Rheinghan's influence. Rheinghan's influence is caused by spiral vortex filaments that rotate at a speed lower than the turbine RPM. The load range at which the Rheingans influence occurred varied in this case, depending upon the up and down stream water level. The problem was that the vibration supervisory system did not register any excessive levels during the transient, so the operators who were located at a remote location, did not know what load ranges to avoid. The spectra shown in Figure 1 were taken from shaft proximity probes while the problem was present.

The above plots taken with a spectrum analyzer that was DC coupled showed that there was no difficulty in detecting the vibration. The reason that the supervisory did not detect the 15 cpm vibration caused by the Rheinghan effect was that its AC coupling capacitor filtered out the vibration. Since nothing can be done to prevent the Rheinghan effect, modifications to the supervisory system are being considered to allow the operators to at least avoid the unstable load ranges.
